DEPARTMENT OF TRANSPORTATION

Contract #: 04-0120F4Cty: SF/ALA Rte: 80 PM: 13.2/13.9File #: 69.28**WELDING INSPECTION REPORT****Resident Engineer:**Siegenthaler, Peter**Address:** 333 Burma Road**City:** Oakland, CA 94607**Report No:** WIR-022580**Date Inspected:** 13-Apr-2011**Project Name:** SAS Superstructure**OSM Arrival Time:** 700**Prime Contractor:** American Bridge/Fluor Enterprises, a JV**OSM Departure Time:** 1900**Contractor:** Zhenhua Port Machinery Company, Ltd (ZPMC), Changxing Island **Location:** Shanghai, China**CWI Name:** Li Yang and Zhu Zhong Hai**CWI Present:** Yes No**Inspected CWI report:** Yes No N/A**Rod Oven in Use:** Yes No N/A**Electrode to specification:** Yes No N/A**Weld Procedures Followed:** Yes No N/A**Qualified Welders:** Yes No N/A**Verified Joint Fit-up:** Yes No N/A**Approved Drawings:** Yes No N/A**Approved WPS:** Yes No N/A**Delayed / Cancelled:** Yes No N/A**Bridge No:** 34-0006**Component:** OBG Trial Assembly**Summary of Items Observed:**

WELDING INSPECTION REPORT

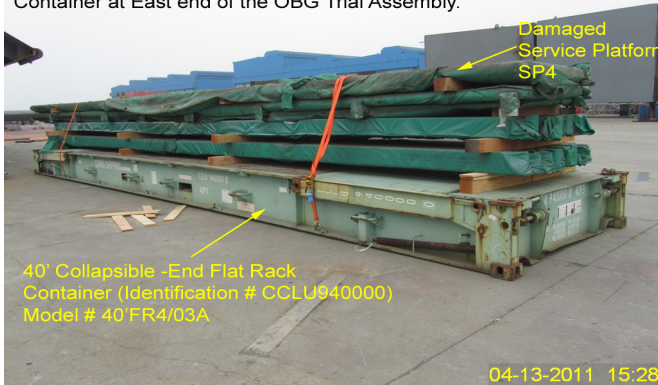
This Quality Assurance (QA) Inspector wrote an Incident Report for handling damage of Service Platform while loading on 40' Collapsible End Flat Rack Container. Please reference the Incident Report # 04-0120F4_TL-15_B278_04-13-2011_Service Platform_SP4_Impact Damage dated April 13, 2011 for further detail.

Service Platform SP#4, mechanical damaged during loading/handling (by fork lift truck) while placing on 40' Collapsible -End Flat Rack Container at East end of the OBG Trial Assembly.

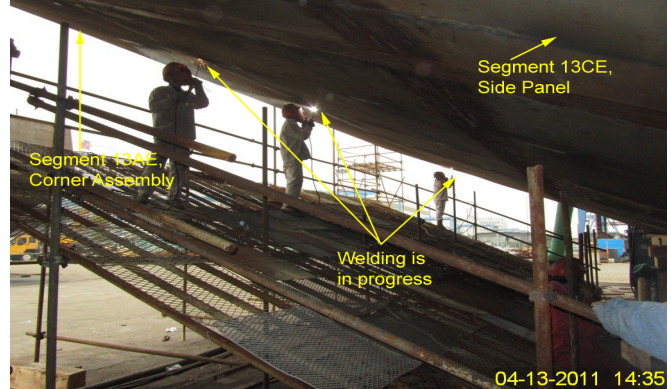
Segment 13CE, Side Panel to Corner Assembly connecting weld, welding is in progress at Cross Beam side at OBG Trial Assembly.

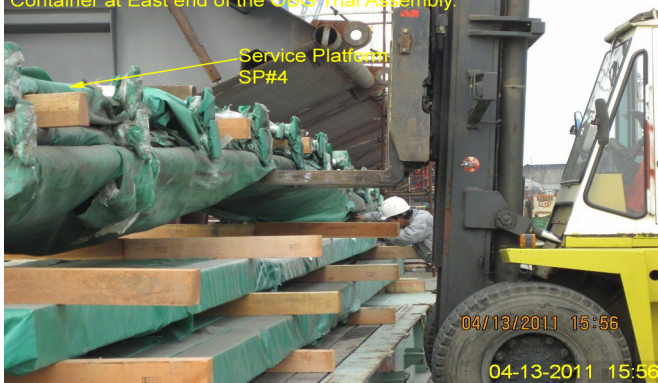
Service Platform SP#4, mechanical damaged during loading/handling (by fork lift truck) while placing on 40' Collapsible -End Flat Rack Container at East end of the OBG Trial Assembly.

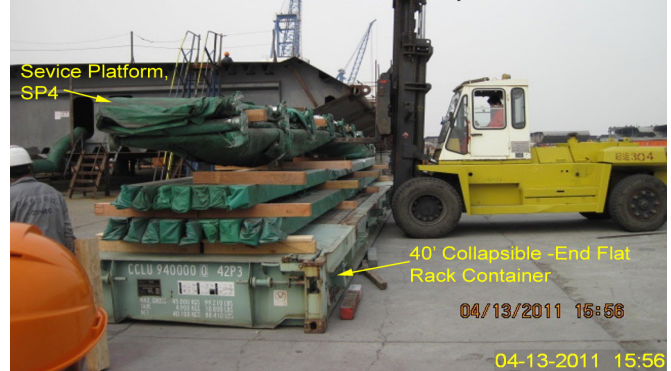
Service Platform SP#4, mechanical damaged during loading/handling (by fork lift truck) while placing on 40' Collapsible -End Flat Rack Container at East end of the OBG Trial Assembly.
